### **Diverter Flashing at Roof/Wall Intersection**

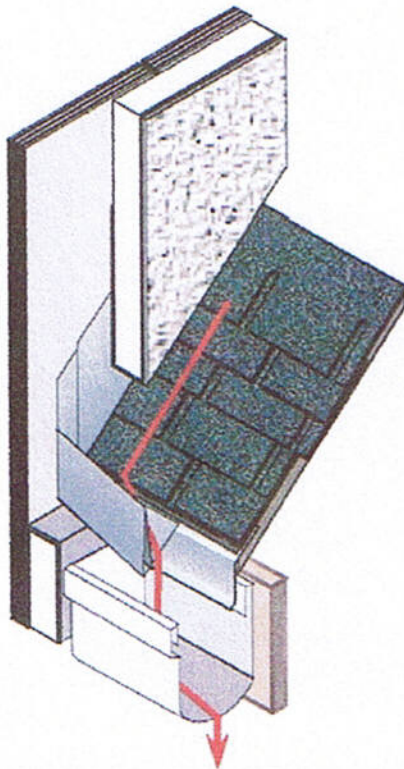
**Figure 4:** Diverter flashing at Roof / wall intersection

Where roofs and walls adjoin (figure 4) step flashing should be installed to keep water from entering the seam between them. Where the roofline terminates, the wall cladding immediately beneath it will suffer water intrusion unless an end piece of flashing with a bend in it is installed to divert water beyond the face of the cladding.

***Missing "Kickout" or diverter flashings at roof-wall intersections are a common source of leaks behind stucco. The failure can be catastrophic.***
